**SAS Superstructure**

Daily Diary Report by Bid Item

Contract No.: 04-0120F4

Diary #: 037 Const Calendar Day: 237 Date: 03-May-2010 Monday

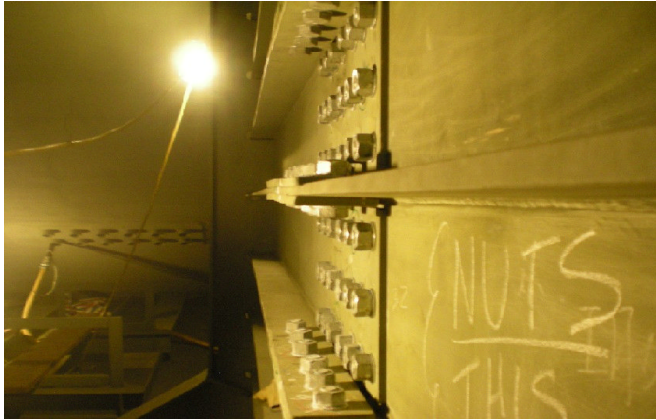
- 7- Longitudinal straightness of the CB1 stiffeners: CB1 connections to OBGs were checked with the help of victor. The bottom connections, and the side connections up to half of the CB1 height were checked completely. Since the longitudinal stiffeners are subject to compressive stress, the limit of $d \leq L/480$ for straightness based on the special provision governs. The maximum measured stiffeners out of straightness at the CB1 was measured to be 7 mm, which is less than the allowable limit, $5340/480 = 11$ mm. However, shim plates could have solved the problem. Please see the attached picture.

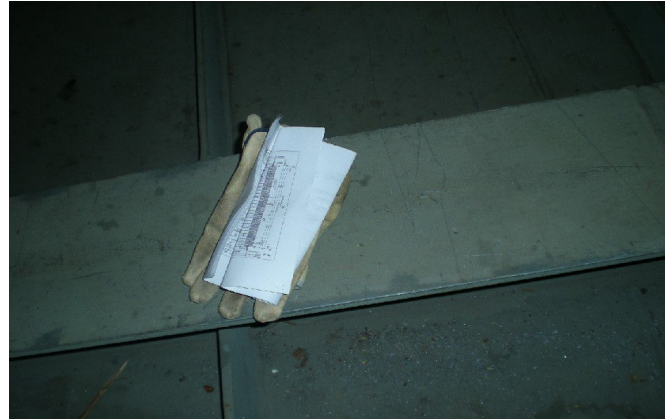
- 8- Vertical misalignment of the CB1 stiffener connections to OBGs: With respect to the attached pictures, the vertical misalignment in a some of the stiffeners connection reaches 4 mm up to 5 mm.

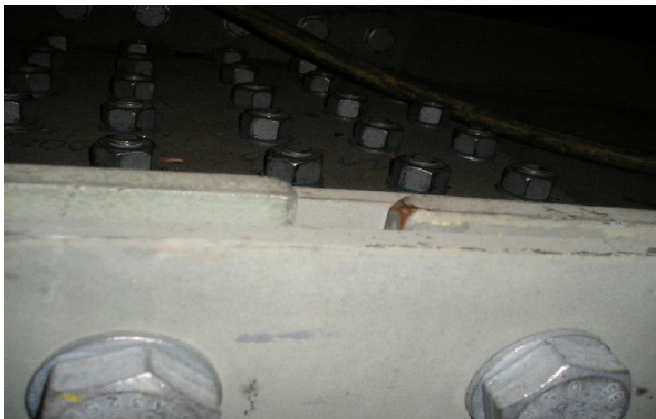
- 9- All the CB1 walls have bulging problem at the splice points, this bulging is inward and is around 10 mm. Please see the attached picture.
- 10- All the stiffeners at the splice points have flatness issues or in the other term misalignment problem both longitudinally and laterally.
